Cyclic test data of two mixed RC-URM wall structures

Alessandro Paparo and Katrin Beyer

Earthquake Engineering and Structural Dynamics Laboratory (EESD), School of Architecture, Civil and Environmental Engineering (ENAC), École Polytechnique Fédérale de Lausanne (EPFL)

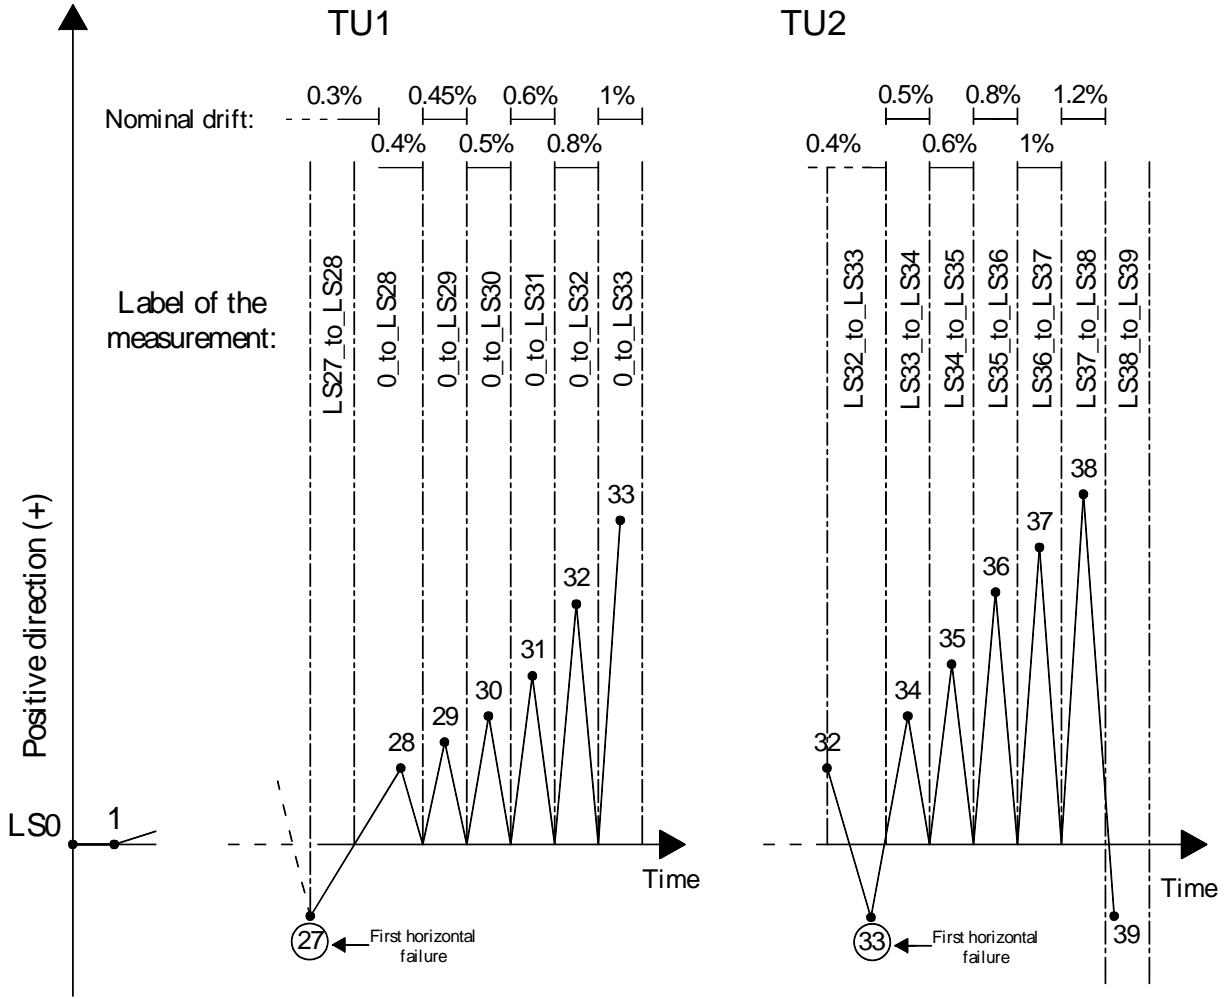
Figure 8: Labels of the measurements for TU1 and TU2 after the first horizontal failure (LS27 and LS33).

force). Different labelling for TU1 and TU2 was used, and Figure 8 resumes the names of each measurement with respect to the nominal drift.

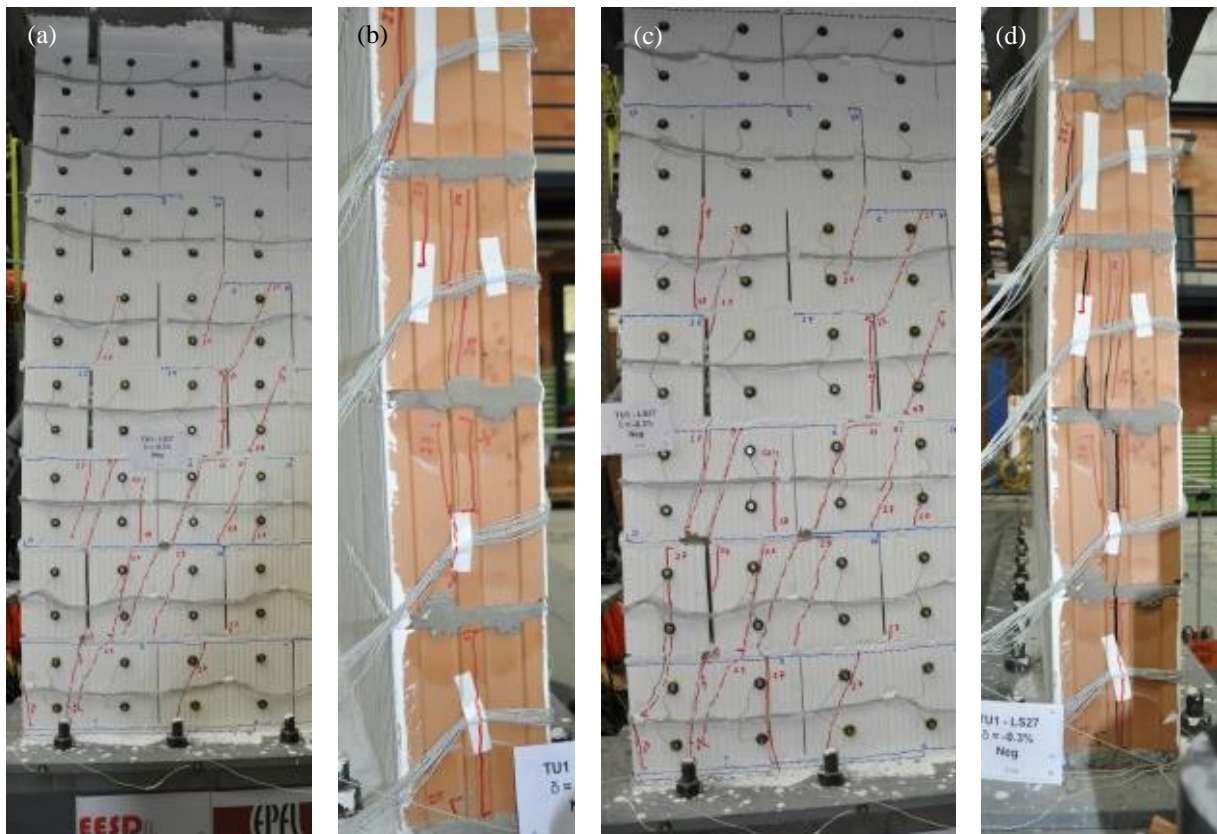
Figure 12: Crack pattern at LS27 ($\delta = -0.3\%$) of the compressed corner of the first storey of the URM wall. Before (a, b) and after (c, d) the horizontal load failure.

At LS27, when the target average drift of $\delta = -0.3\%$ was reached, the horizontal load was stopped, photos were taken and cracks were marked. In the first storey of the URM wall, inclined shear cracks and the onset of toe-crushing were observed. In the second storey of the URM wall, only thin inclined shear cracks appeared (Figures 11a, 12a and 12b). During the crack marking, a relaxation in the URM wall occurred: the number of cracks in the compressed corner grew, the shear strength of the URM wall rapidly decreased and the specimen attained horizontal load failure. In order to avoid axial load failure of the URM wall, the horizontal load was reduced to zero. Figures 11b, 12c and 12d show the specimen crack pattern after the strength degradation of the URM wall.

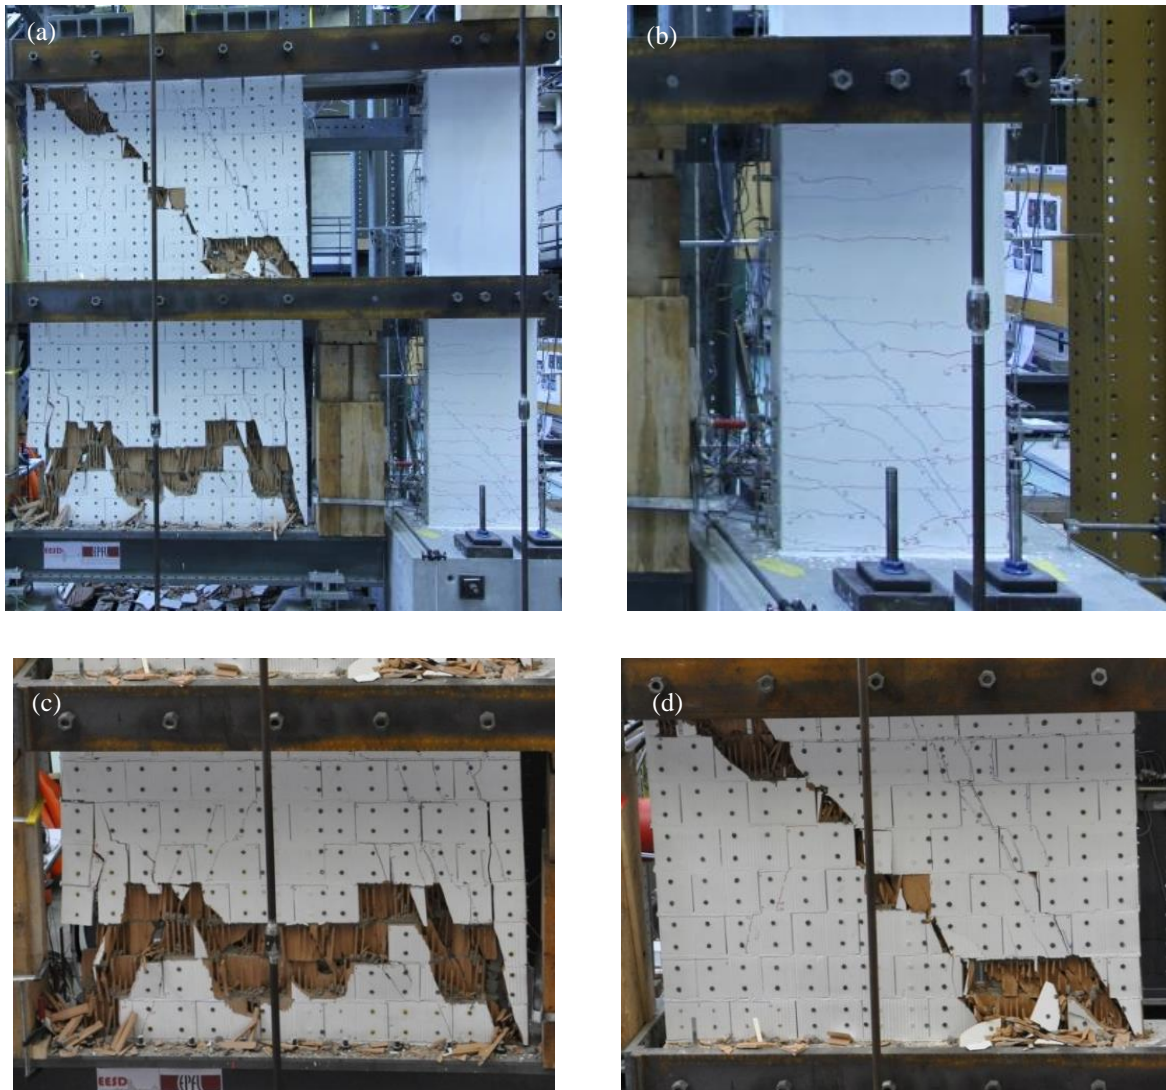
The axial load failure of the first storey of the URM wall, due to the crushing of the compressed toe, was quickly followed by the horizontal load failure. Figure 14a shows that in the URM wall the cracks were not concentrated in the bottom storey, as is typical for URM walls, but they also spread up to the second storey because of the presence of the RC wall that changed the global deformed shape of the system. At the same load step (LS33), the RC wall was still in the pre-peak response and only some of the longitudinal reinforcing bars at the north edge had yielded. The crack pattern of the first storey of the RC wall consisted of horizontal flexure cracks plus some shear-flexure cracks that started developing in the previous cycle (LS32, $\delta = +0.8\%$), as seen in Figure 14b. The second storey of the RC wall exhibited only small cracks in the construction joints. Figures 14c and 14d show the detail of the crack pattern after the failure of the first and second storey of the URM wall.

Figure 14: Crack pattern at LS33, $\delta = +0.95\%$. (a) specimen; (b) RC wall, first storey; (c, d) close-ups of the first and second storey of the URM wall.
