8 Water

Prepared by: Ricardo Serpell, September 2018.

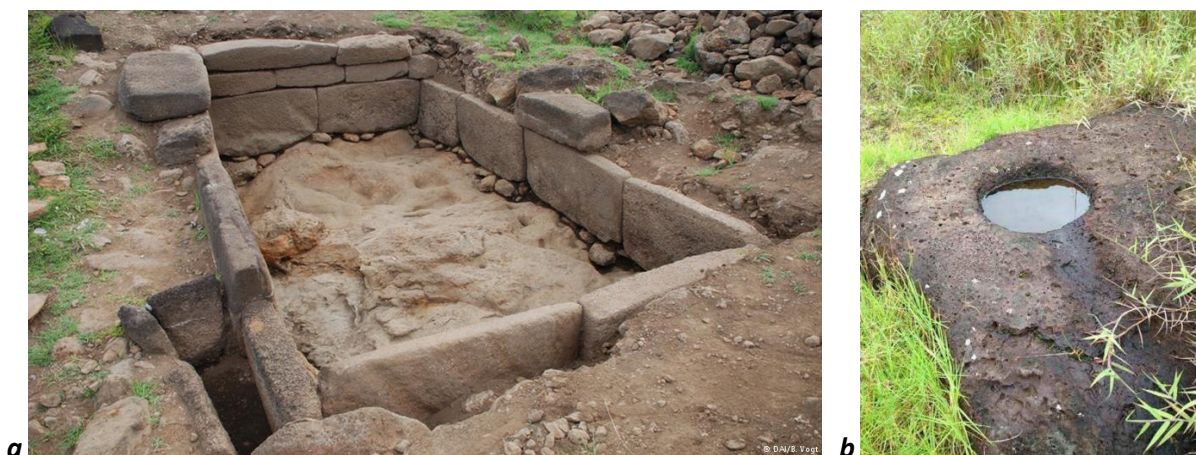
Figure 8.1 **a**: Ancient water reservoir (Vogt). **b**: *Taheta* carved on a stone to collect water (from [7]).

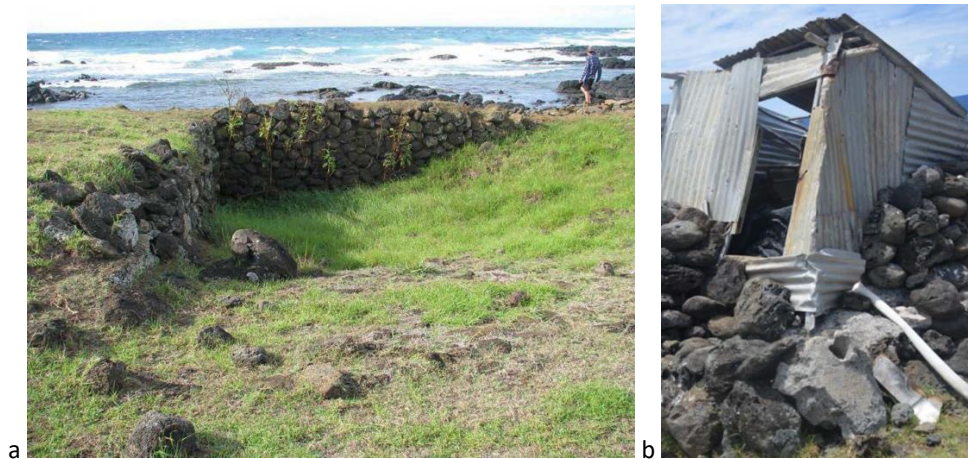
Figure 8.2 **a**: *puna* in the La Perouse bay area, consisting of an open pit and stone lined wall (from [7]), **b**: active well perched on top of a *puna* (from [8]).

Evidence suggests that throughout the period of human occupation predating European contact, the island had experienced several climatic phases and landscape shifts that affected the availability of water for human consumption. According to Rull et al. [1], even if a direct cause-effect relationship cannot be established with available evidence, changing water availability probably affected the cultural development of Rapanui civilization at different stages. The role of these climatic changes on human-resource interactions on Easter Island is still under exploration [2]. Nevertheless, archaeological research has already shown that rain water collection and management appears to have been a common practice at some point in the ancient history of the island [3–7]. Water reservoirs built along ephemeral streams and collectors carved on basaltic stones called *taheta* are found throughout the island (Figure 8.1). A network of man-made wells along the coast of the island, called *puna* (Rapanui word for spring), enabled catchment of a mixture of fresh and saline water (brackish water) in places where underground water flowing from the inner part of the island discharges just above the sea level. Some of this natural springs are still in use today to access water for livestock (Figure 8.2).

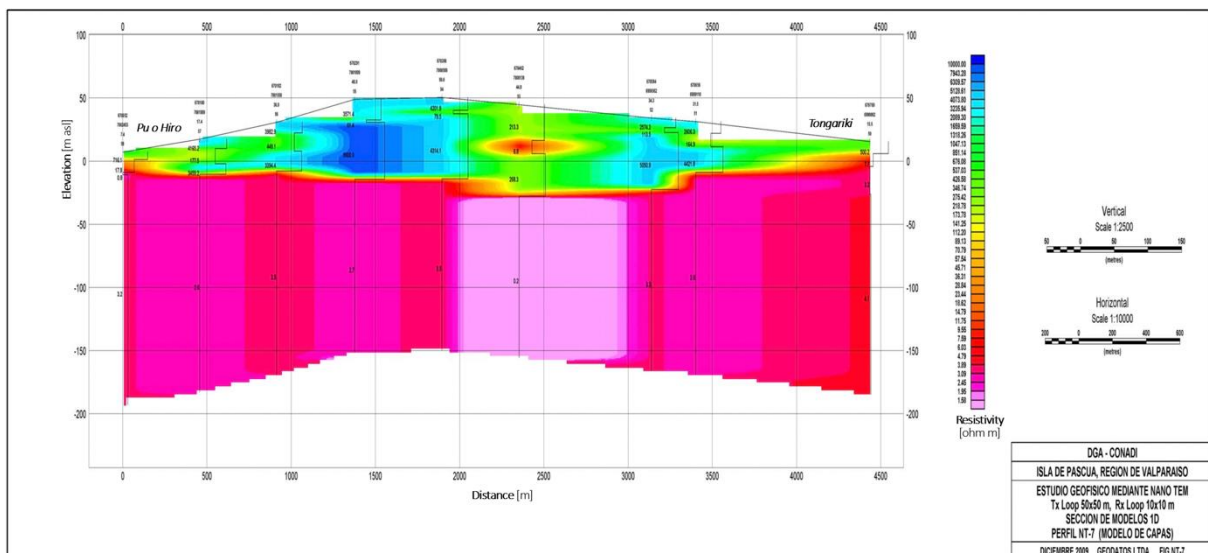
Figure 8.3 Resistivity from TEM data showing fresh/saline water boundary in the north-eastern part of the island (from [10]).

Today, almost all the potable water is sourced from a relatively shallow aquifer that is replenished by infiltration of precipitation through the highly pervious volcanic soil. Despite the small size of the island, average annual precipitation ranges from about 1,000 mm to over 1,500 mm at different locations [9]. Infiltrated groundwater migrates through the permeable volcanic layers of the aquifer and discharges in the sea, mainly through submarine springs and occasionally above the sea level. Considerable mixture of saline and fresh water occurs naturally in the aquifer, particularly near the coast (Figure 8.3).

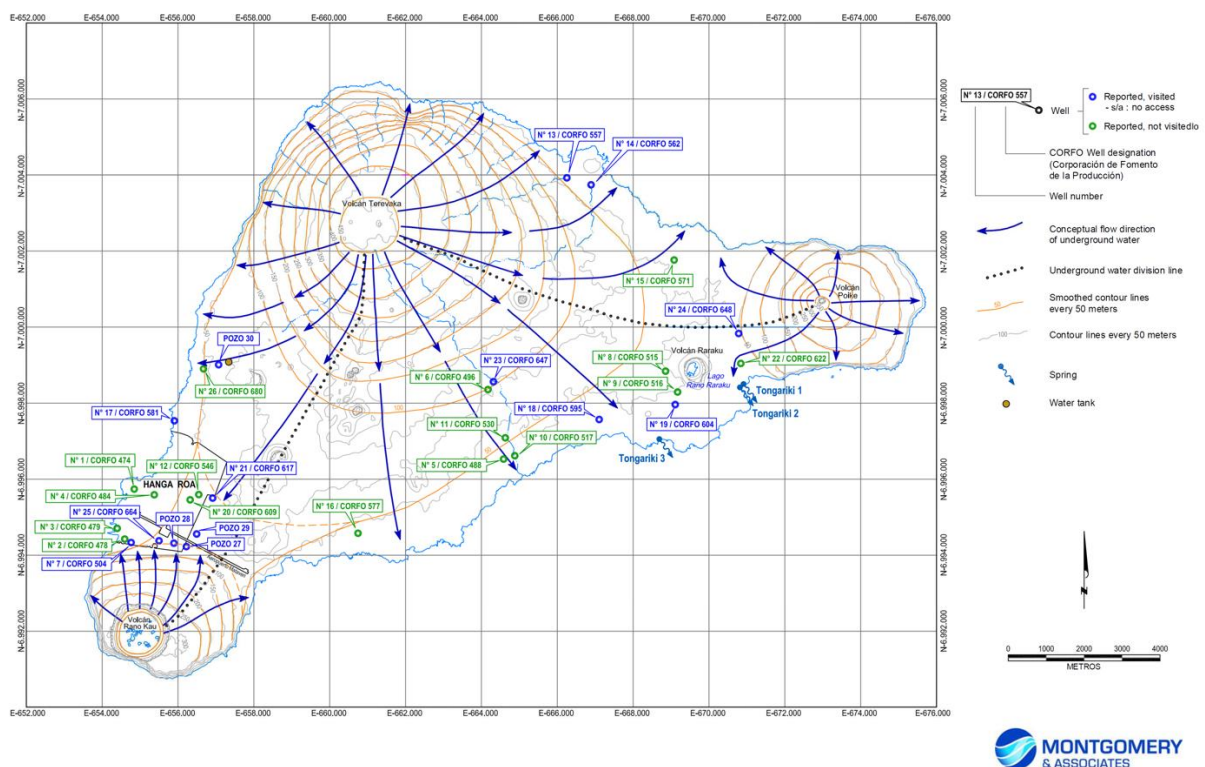
Figure 8.4 Location of wells and estimated underground water flow patterns (from [11]).

exist around Hanga Roa that also pose a risk for contamination of the aquifer (Figure 8.4). Another source of concern is the rate of extraction on the working wells. If the rate increases it can cause uplifting of saline water in the area of the well, increasing salinity of the extracted water. If the drinking water supply becomes irreversibly polluted, implementing an alternative source is not possible without significant social and economic damage to the island.
