# EVA760 Troubleshooting

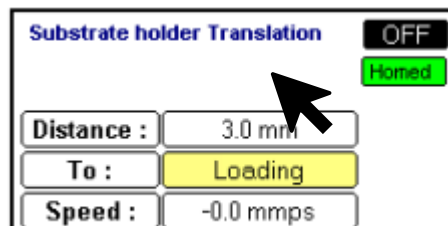
, click on the *Substrate holder Translation* window.

5. Check that the dome is detected in the box *Act Dome Type*. If a dome is detected 450 or 350 or 250 should appear. If not, *No Dome* appears.

Substrate holder Translation		OFF	Homed
To :	Loading	Distance :	3.0 mm
		Speed :	0.0 mm/s
		Act Dome Type :	NO DOME
